Evaluation of the Intersection Confirmation Light With Targeted Enforcement to Reduce Red  
Light Running Violations at Freeway Ramp Intersections

Submitted to the graduate degree program in Civil, Environmental and Architectural Engineering  
and the Graduate Faculty of the University of Kansas in partial fulfillment of the requirement for  
the degree of Master of Science.

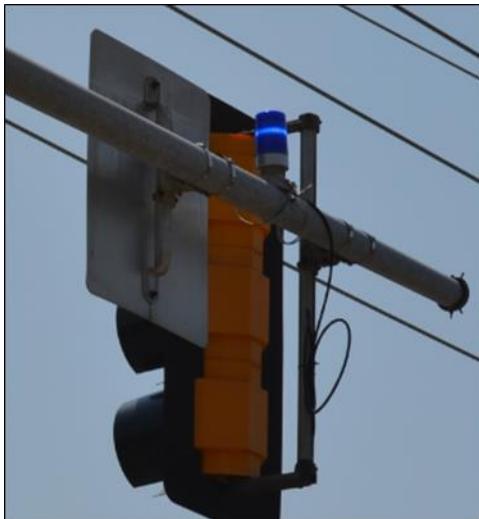
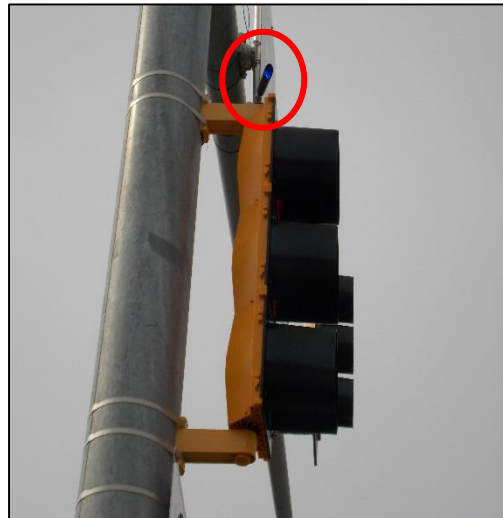
**Figure 1. Varieties of confirmation lights (4)**

Communities without automated enforcement rely on low-cost countermeasures and traditional targeted enforcement to reduce RLR crashes at signalized intersection. An example of low-cost enforcement countermeasures combined with targeted enforcement is shown in Figure 1.

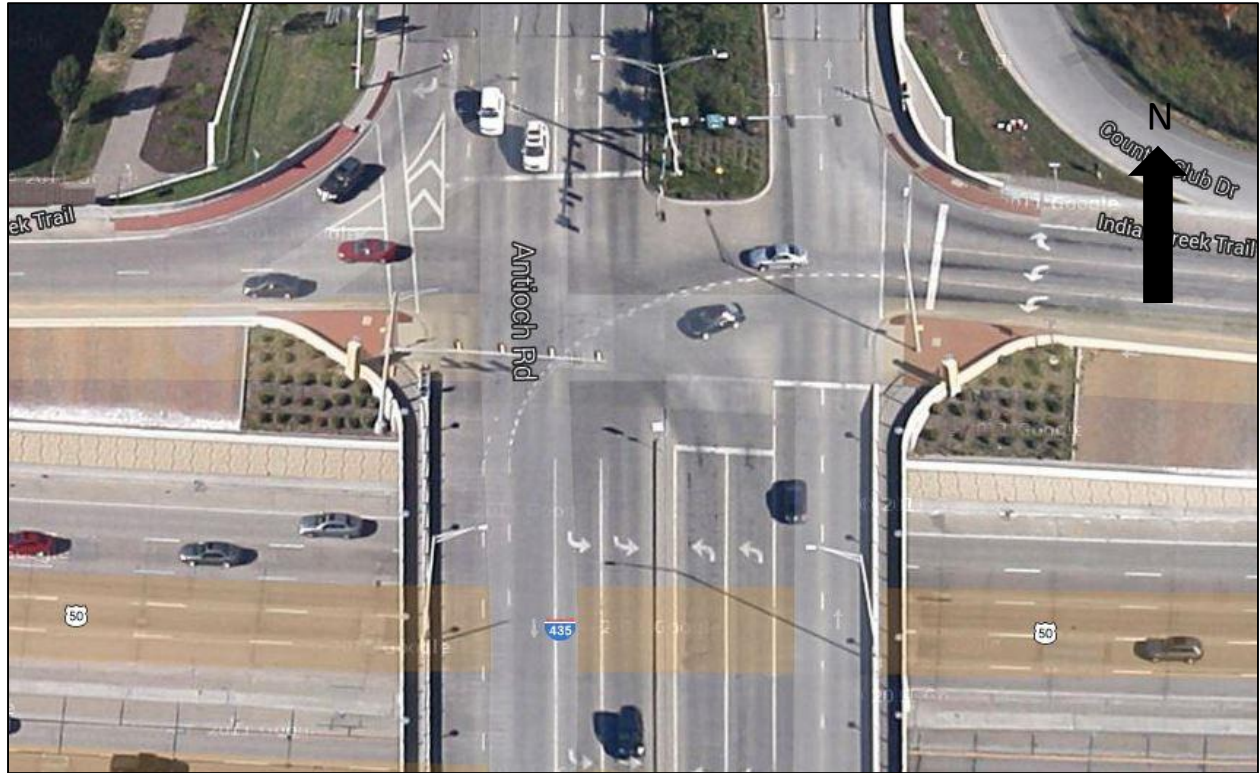
**Figure 5. Aerial view of the intersection of I-435 and Antioch Road North (Google maps, 2015)**

As shown in Figure 5, the intersection consisted of two through lanes and two left turning lanes. A golf course and residential complex are located on the northeast and northwest quadrants of this intersection, respectively. Figure 6 shows the ground view of the intersection.

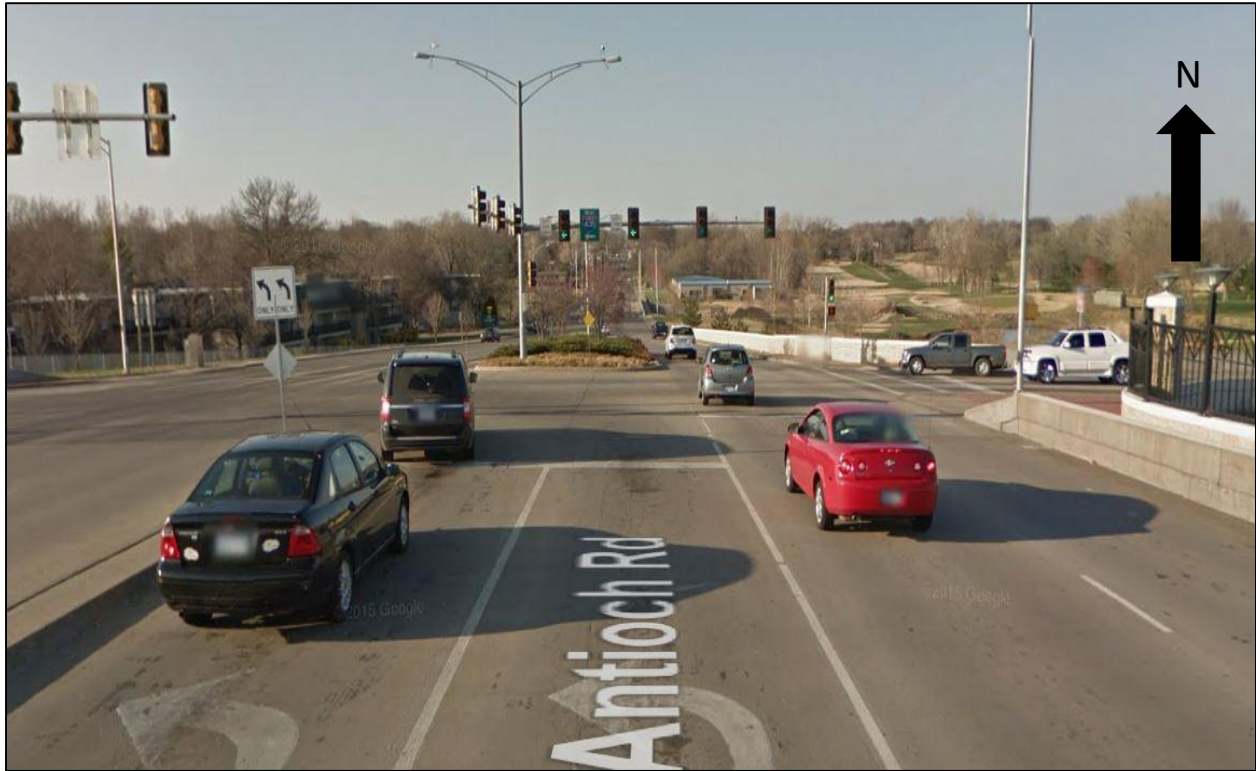
**Figure 6. Ground view of the intersection of I-435 and Antioch North (Google maps, 2015)**

Shown in Figure 6 is a ground view of the intersection looking northbound. All left turn approaches were protected signal heads. The left turn approaches are fully actuated coordinated.

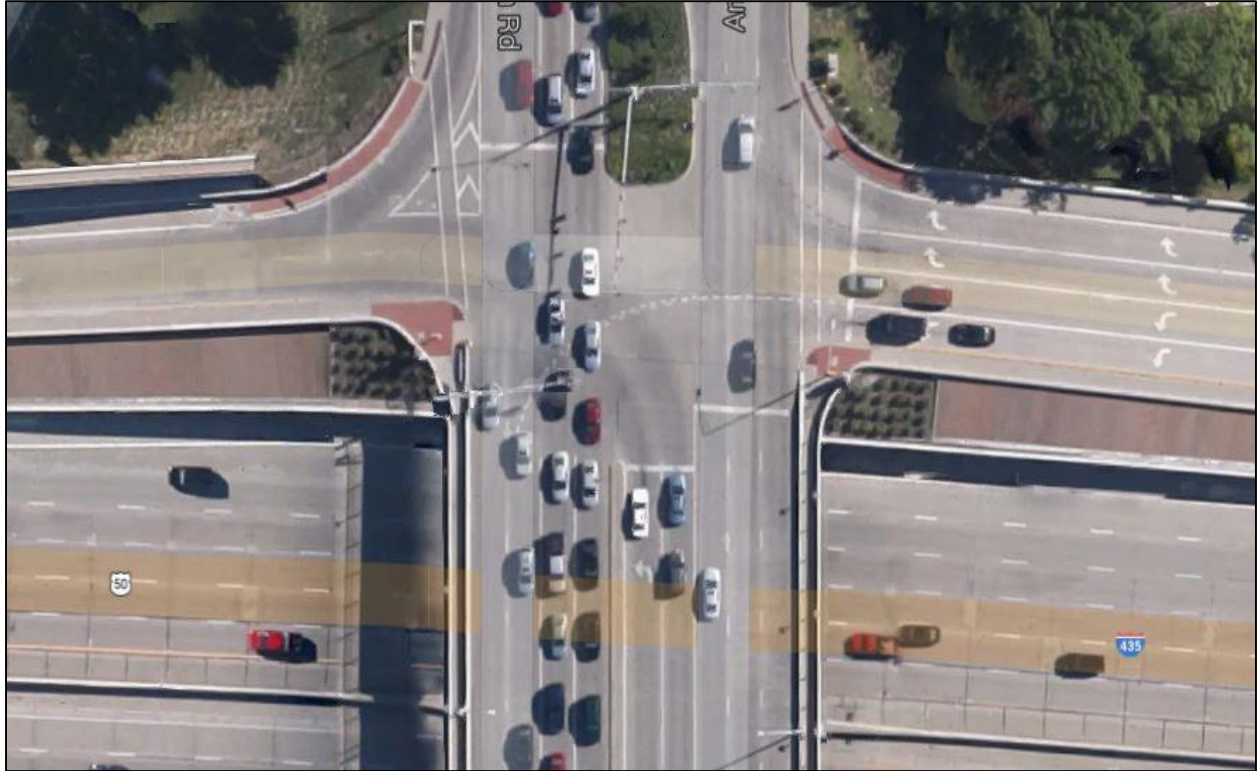
**Figure 7. Aerial view of the intersection I-435 and Antioch Road Southbound (Google maps, 2015)**

As shown by the aerial image in Figure 7, the intersection consists of three through lanes and two left turning lanes. A commercial complex and residential complex are located in the southwest and southeast quadrants of the intersection, respectively.

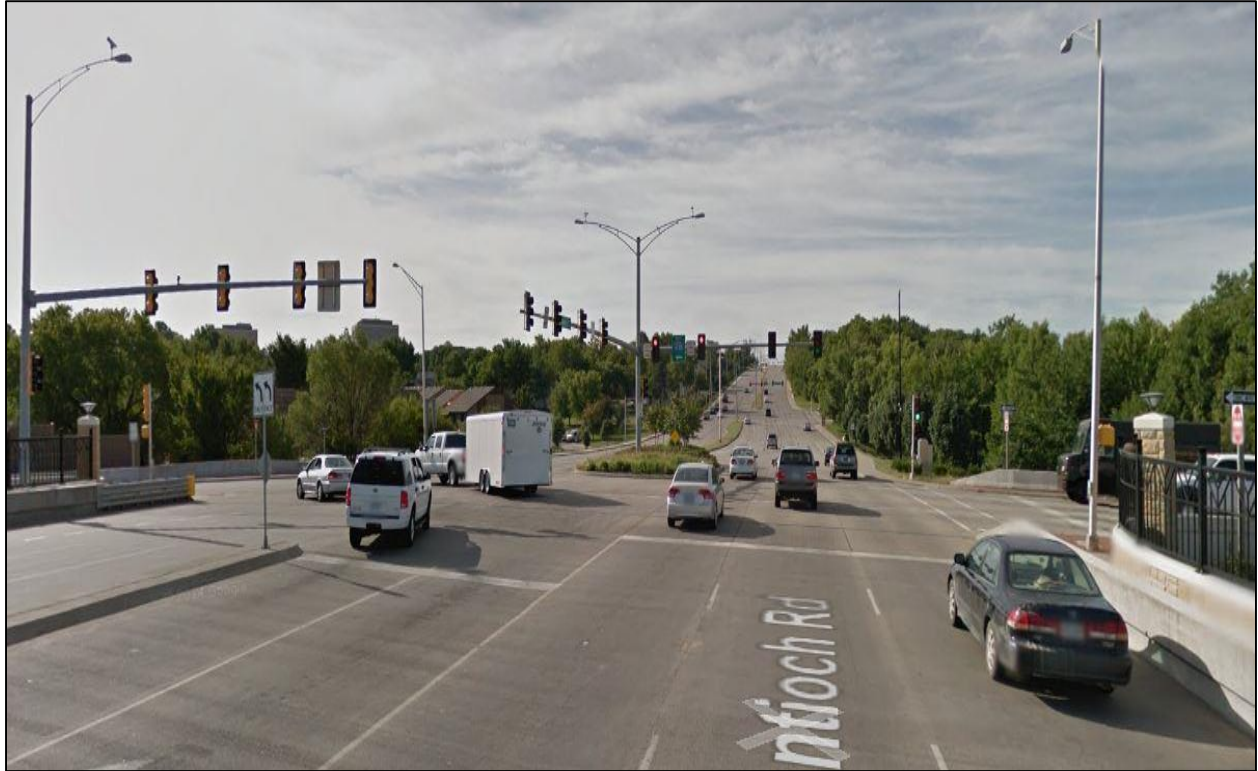
**Figure 8. Ground view of the intersection of I-435 and Antioch Road Southbound (Google maps, 2015)**

Shown in Figure 8 is a ground view of the intersection looking southbound. All left turn approaches were provided protected-only movements. Left turn approaches are fully actuated signals for most part of the day. This intersection served higher volumes during the evening peak hours.

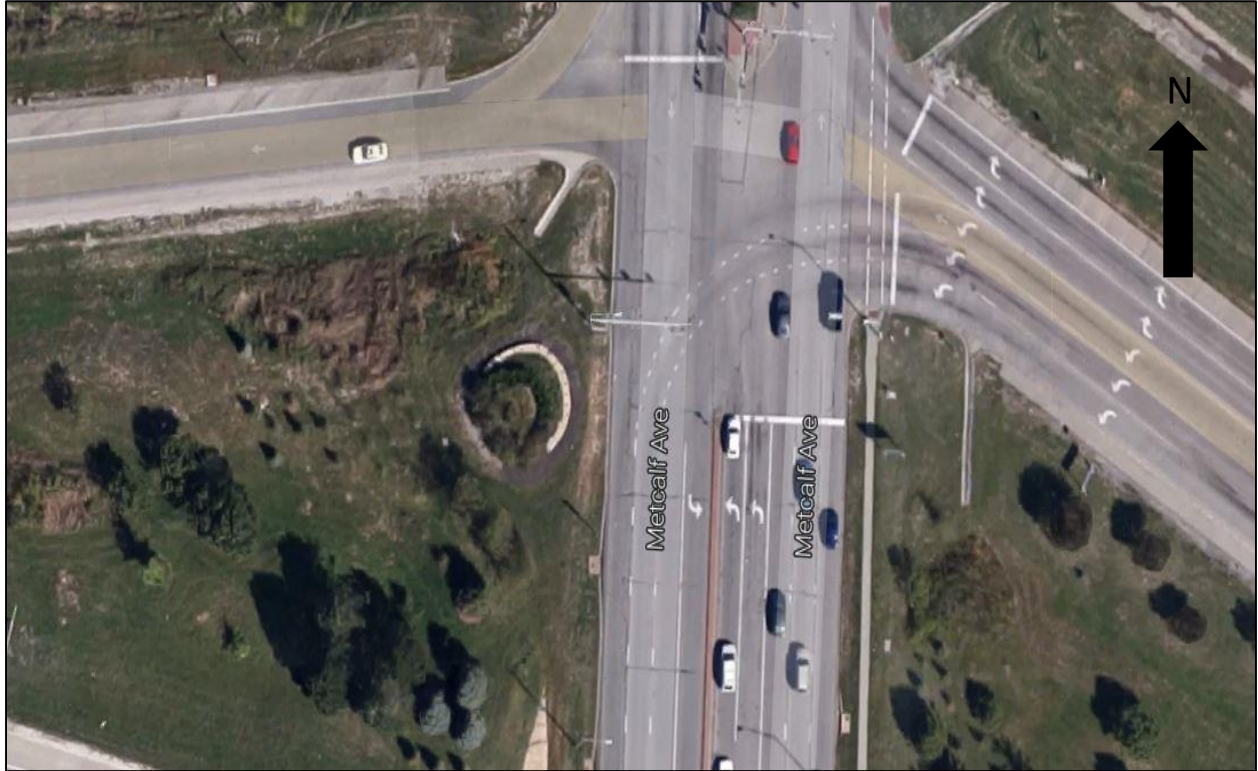
**Figure 9. Aerial view of the intersection of I-435 and Metcalf Avenue North (Google maps, 2015)**

As shown in Figure 9, the intersection was comprised of three through lanes and two left turning lanes. A hotel and commercial complex were situated on the northeast and northwest quadrants of the intersection, respectively. Figure 10 shows the ground view of the intersection of I-435 and Metcalf Avenue North.

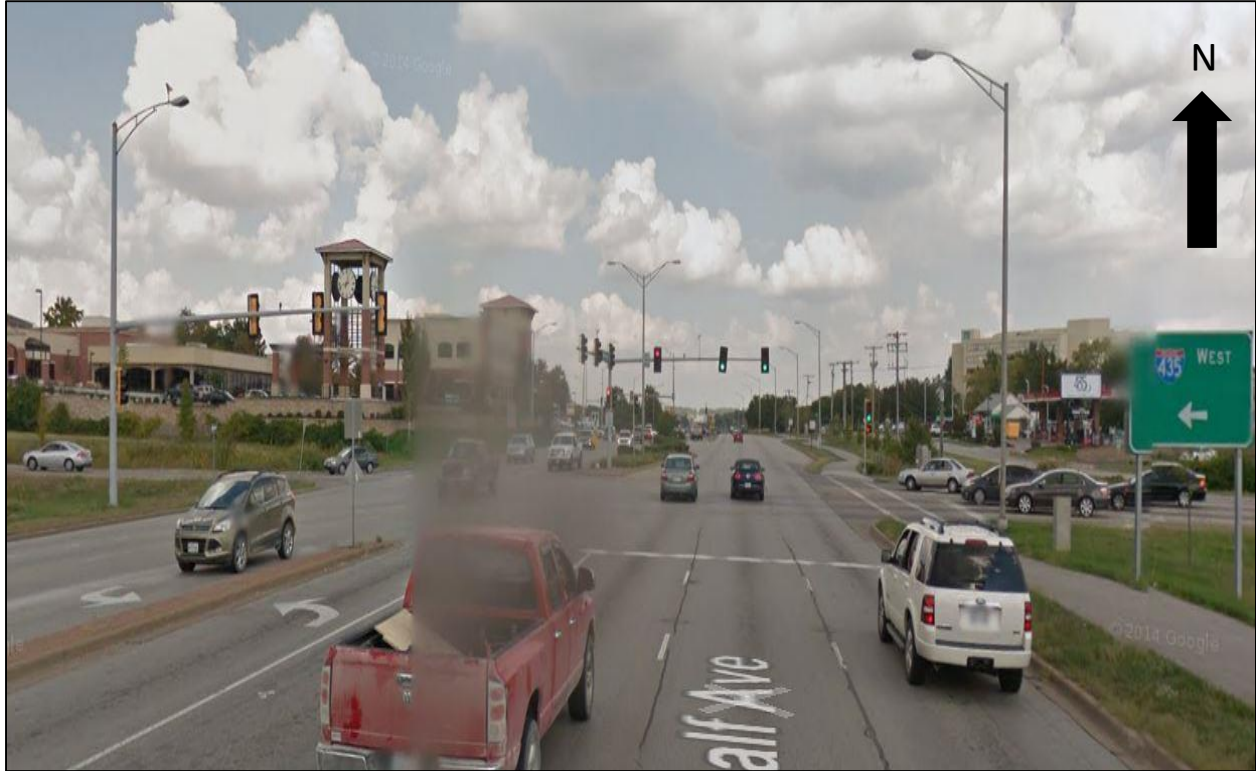
**Figure 10. Ground view of the intersection of I-435 and Metcalf Avenue North (Google maps, 2015)**

Shown in Figure 10 is a ground view of the intersection looking northbound. All left turn approaches were protected signals. Left turn approaches are fully actuated. Most the traffic consisted of commercial and commuter passenger cars.

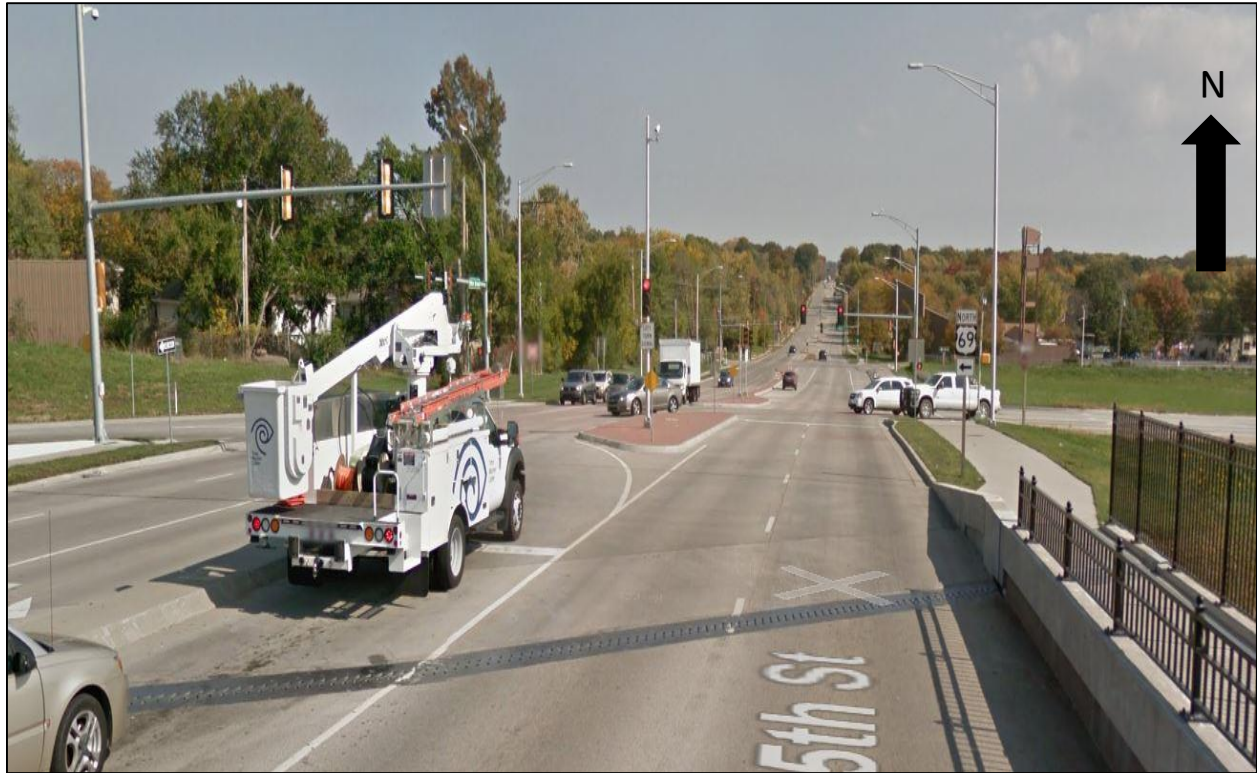
**Figure 11. Ground view of intersection of US-69 and 95th Street (Google maps, 2015)**

As shown in the Figure 11, the intersection consisted of two through lanes and one channelized left turning lane. This intersection is surrounded by residential areas. The left turning lane was a protected-only left turn lane.

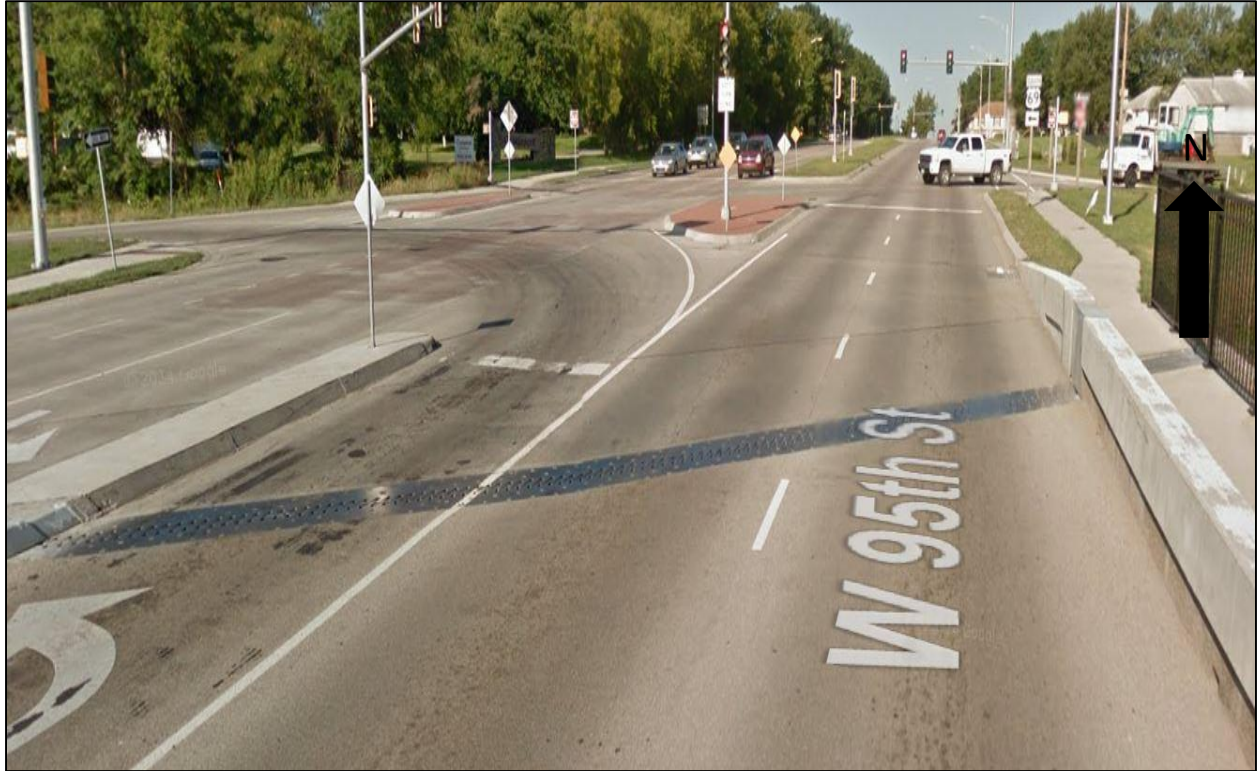
**Figure 12. Ground view of intersection of US-69 and 95th Street West (Google maps, 2015)**

Figure 12 shows that the intersection consisted of two through lanes and one channelized left turning lane. Residential areas were located on northwest and southwest quadrants of this intersection.

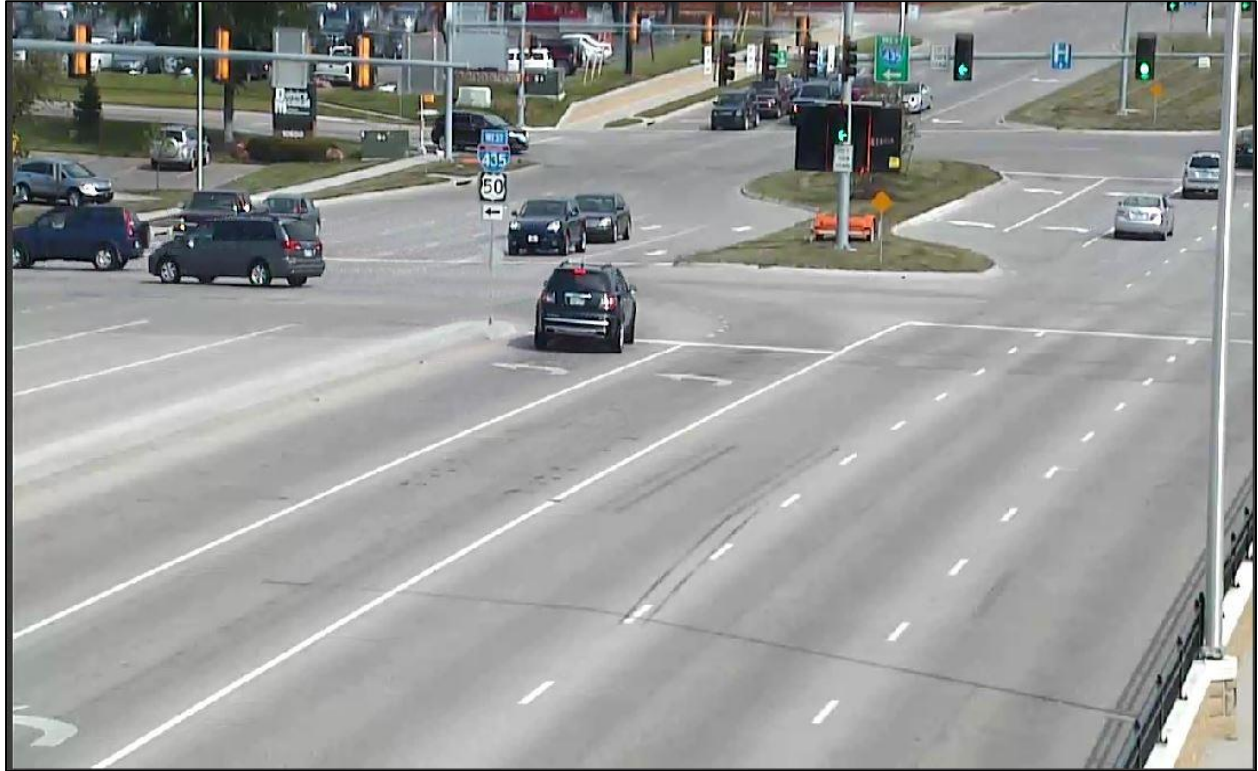
**Figure 13. Overhead camera view of an intersection northbound approach**

Figure 13 shows a view of an intersection in which a single approach could be monitored. As stated in the previous section, all the intersections under investigation were monitored only for left turning movements towards the on-ramps. The field view was needed to view the approach stop line and current phase of the signal. As shown in Figure 13, the recorded field of view by the overhead camera showed the stop line, and the vehicles. All of this was used to determine the number of violations and time into red (seconds).

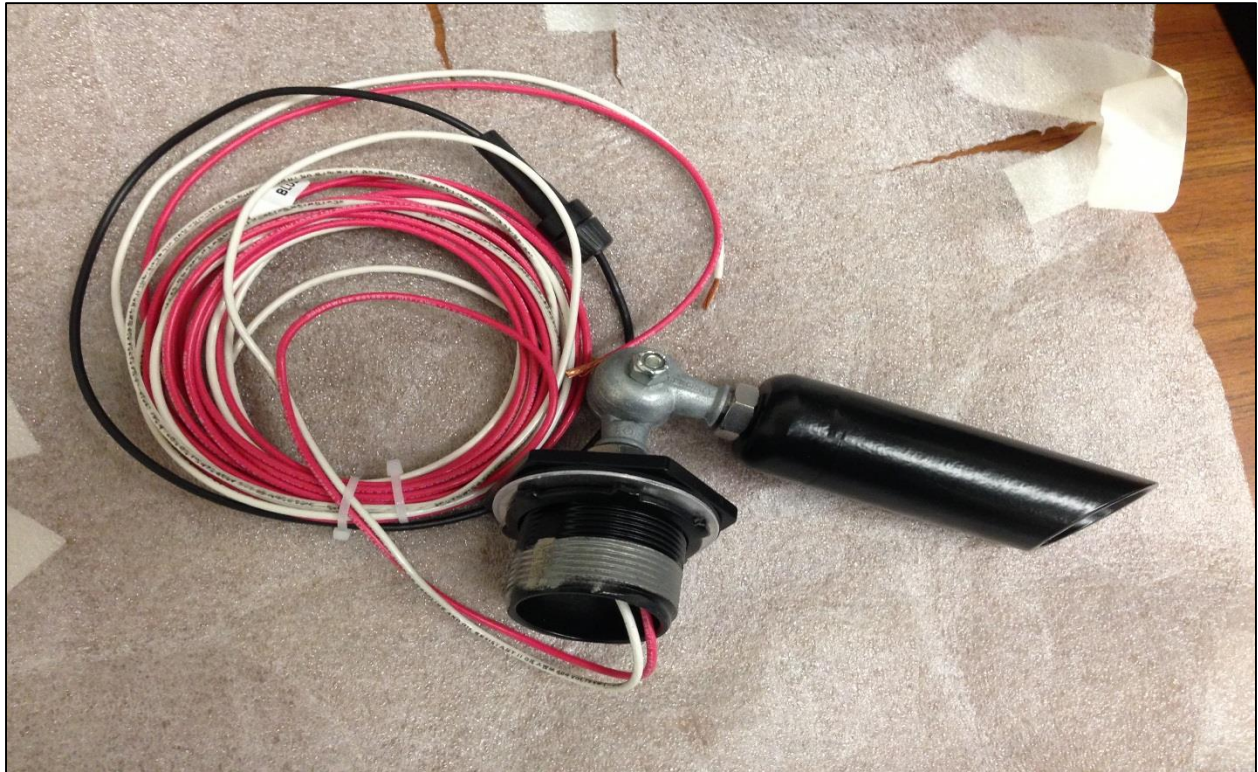
**Figure 18. Confirmation light before installation**

Figure 18, shows the confirmation light as provided by the manufacturer. A standard two-wire light was ordered without the ground wire after consulting with the Overland Park traffic technicians.

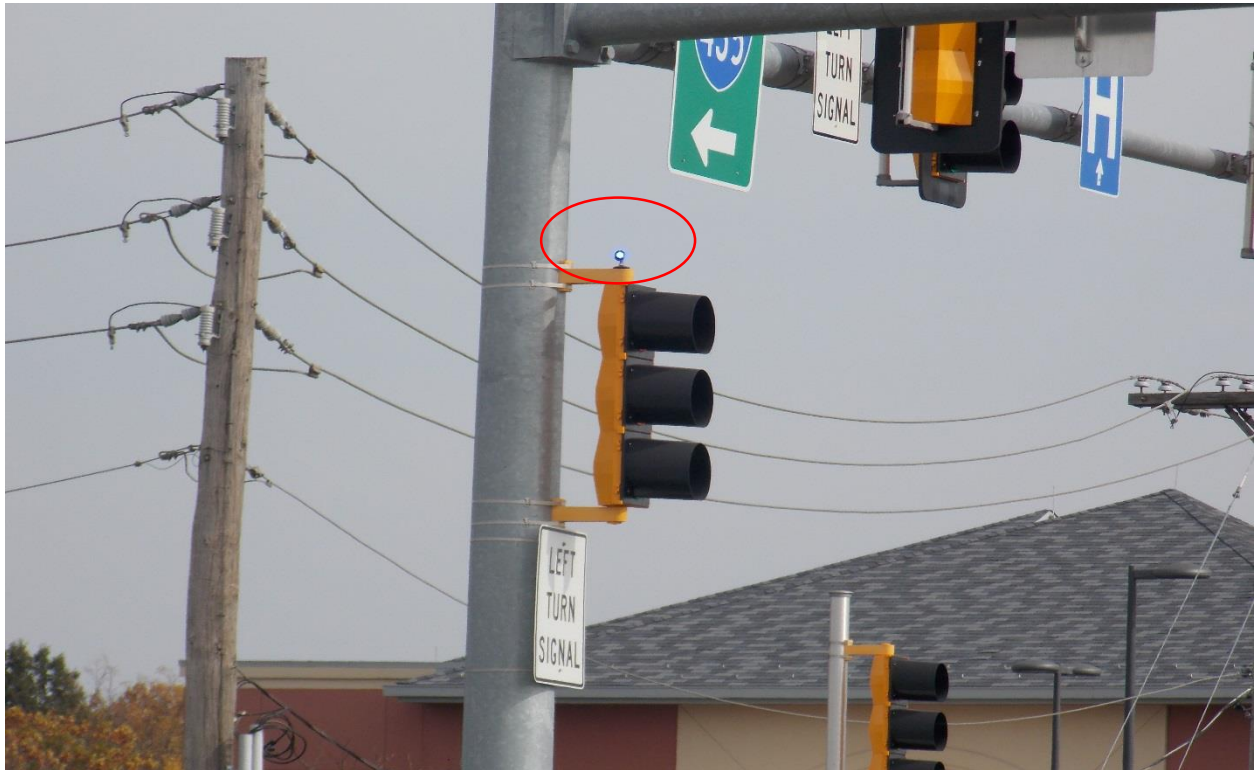
**Figure 19. Confirmation light installed on left turning movement traffic signal**

The Figure 19 shows a working of a confirmation light installed on the left turning traffic signal at the intersection of I-435 and Quivera Road North in Overland Park, Kansas. The photo was taken where an officer in a patrol car would observe the light from the on-ramp. The confirmation lights were installed on the left turn signal at both intersections (I-435 & Quivera Road North and I-435 & Quivera Road South) on September 10, 2014.
